Failure analysis of geothermal API 5L grade B steel pipeline

J. Obiko^{a*}, M. Ndeto^b, J. Mutua^b, B. Shongwe^a, N. Malatji^a, M. Bodunrin^c and D. Klenam^c

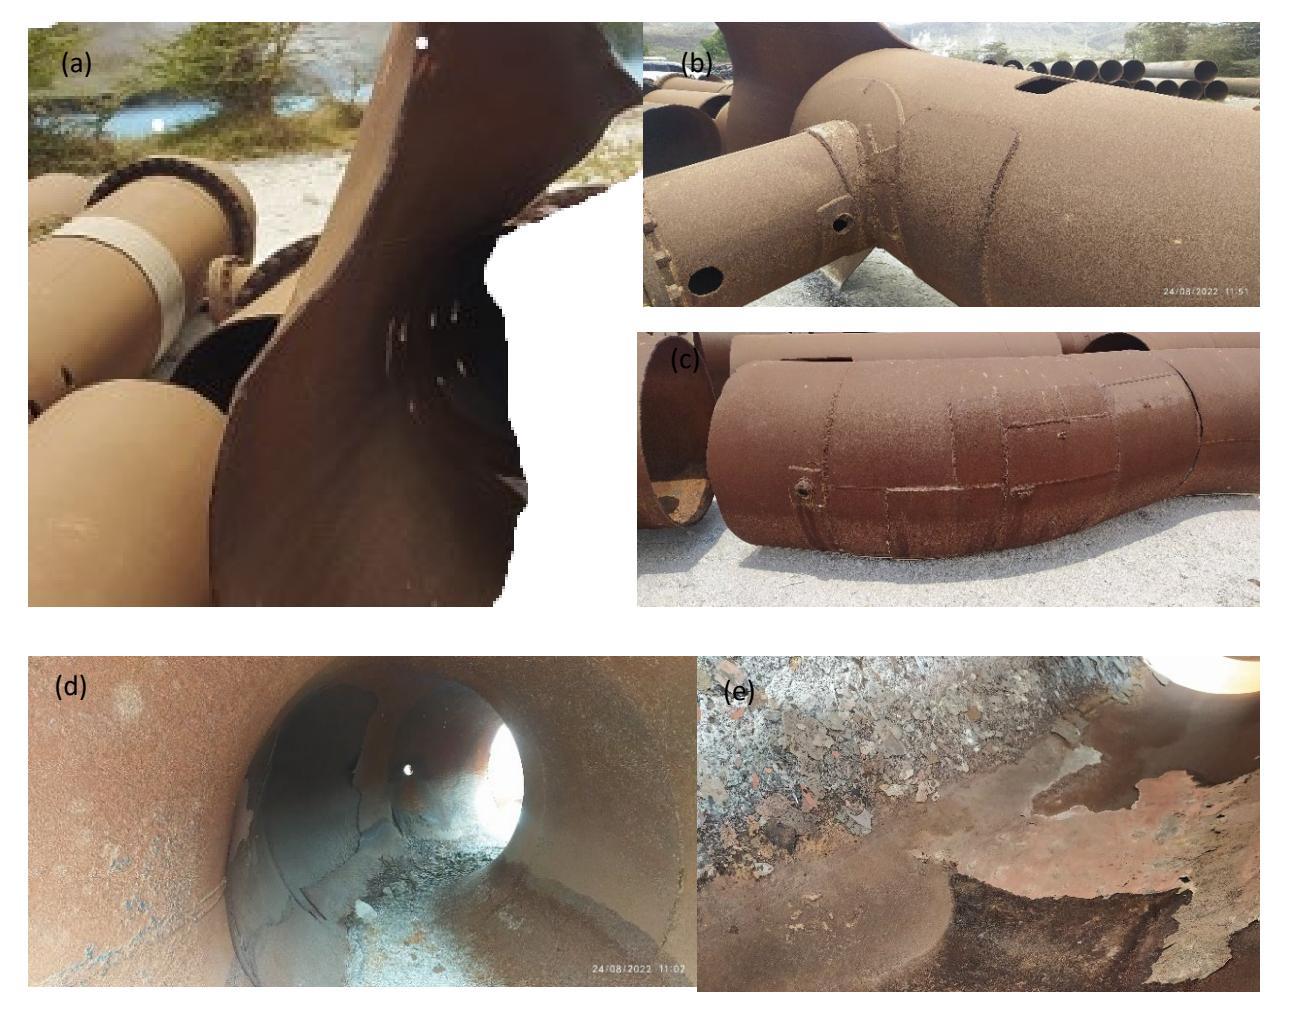
Fig. 1 shows photo images of different positions of geothermal steam pipeline failed sections. The extent and nature of the rupture indicate a catastrophic failure. Visual inspection revealed a significantly localised wall thinning of the pipeline. The pipe wall thickness measurement on the failed pipe was 3 mm, far less than the 12.7 mm measured for the upper side of the uncorroded pipe section. The failed steam pipeline had scales on the internal and external surfaces (**Fig. 1**). The steam pipeline failed after six years of operation. The cause of failure was due to high corrosion rates resulting from service conditions. The steam pipe thinning occurred over a period due to corrosion occurring near the drain port. The variation of steam temperature and pressure resulted in circumferentially pipe failure.

The failure cause was determined by sectioning the failed pipe section in as-received condition for microstructure characterisation. After six years of service, the analysis revealed that erosion corrosion caused the steam pipe to undergo severe thinner at sections near the drain port and in the bend, as illustrated in Fig. 2. The steam pipe scaling particles were present in the collected geothermal fluid. The scaling in the pipes appeared loose and porous. Regions that experienced turbulent and low-angle impeachment of steam flow had no scales adhered to the metal surfaces. The reason is that the scales fell off over time due to high service pressure as the material decomposed from the parent steel pipeline. The results further indicate that active erosion-corrosion is a cause of pipeline failure.

Fig. 1. Photographs of failed geothermal steam pipeline failure. (a) Ruptured pipe from original construction; (b) Repaired pipe around a drain port; (c) Repaired pipe around a bend; (d) & (e) Scaling and corrosion in pipes.

The study observed that the steam pipeline undergoes erosion-corrosion processes and metal deposits over time. Therefore, the steam pipeline failed due to corrosion damage resulting from erosion-corrosion. The deposits formed due to the chemical reaction between solid particles and steam with reactive agents such as hydrogen sulfide. Due to the fluid's low velocity, the solid particles and deposits cause erosion-corrosion at the particle and surface interface. The lower section of the steam pipe, especially at liquid discharge ports and pipe bends, experienced severe corrosion. The failure started gradually during the pipeline service and grew incrementally. The pipe wall thinning occurred due to the geothermal fluid/steam and pipe wall interaction. The study points out that the material selection for this application was not well-guided. Therefore, these sections of the steam pipeline require materials that are corrosive resistant with good creep strength. This approach will ensure the safety of the pipeline system and the operators and reduction in maintenance costs. The study also revealed that unprocedural maintenance procedures such as weld repair might have also accelerated corrosion activities.

The flow direction and velocity changes may cause the elbow to thin. This action significantly increases corrosion behaviour. For example, flow-accelerated corrosion occurs at the elbow and T-sections of the drain ports. The study observed that the tribocorrosion mechanism was the dominant corrosion mechanism. Hence, this mechanism damaged the surface layer and the base metal. This corrosion mechanism (erosion corrosion) in these steam pipelines caused localised thinning, thus causing weak sections. The scale of rupture of the pipeline material points towards a condensation-induced hammer near a drain port. Condensation occurs even for the insulated pipes due to heat transfer to the outside, but occasionally clogging or malfunctioning, allowing condensate to build up. The steam pressure, temperature and fluid velocities contribute to the intensity of hammer events. The generation of pressure waves occurs, causing the weakest section of the pipeline to rupture.

- 1. During material selection, corrosion resistance material should be considered for this application. The steam pipe should meet the minimum strength and corrosion requirement for service application in geothermal power plants.

- 2. Economically, the study recommends the use of corrosion-resistant steel to avoid repeated maintenance costs.
- 3. During operation, the study recommends that the pipeline system have steam traps. These traps will assist in the condensate removal whenever it forms. This design will ensure that the steam is dry.

- 4. Reduce the intensity of geothermal power plant metals' general corrosion by the inhibitory effect of surfactants and protective films on metal. The study also recommends coatings and linings for pipes above ground or underground.

- 5. The wall thickness at the affected areas, especially the lower side of the pipeline, all elbows and near the drain port, should have a higher thickness.

- 6. Routine checks of pipelines using ultrasonic waves will ensure proper monitoring of corrosion evolution in pipelines and the related wall thinning in the framework of maintenance operations.

- 7. Monitor and remove condensate periodically to keep the steam dry and maintain records to keep in check the trends of condensate formation and quantities.

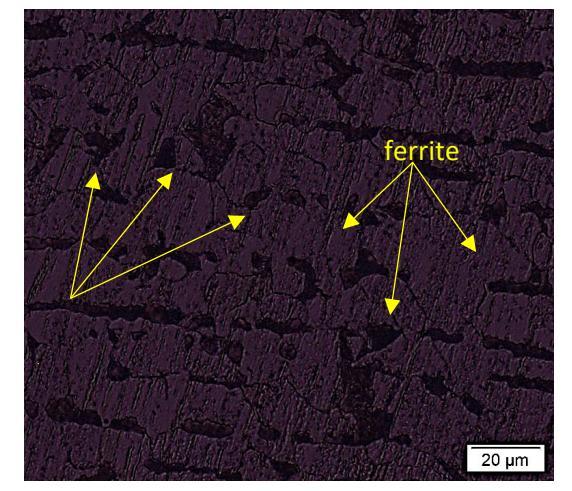
Fig. 3 shows the optical image micrograph of the pipe investigated in this study. The image shows that the microstructure had ferrite and pearlite. This microstructure is commonly observed in low-carbon steels, thus reflecting the chemical composition shown in Table 1. Fig. 4 shows the SEM-BSE image of the pipe studied. The image shows that the microstructure exhibited well-defined ferrite and pearlite phases. The ferrite is the dominant phase. The study observed pores on the microstructure caused by pitting corrosion. The pitting pits may act as a crack initiation site, causing stress corrosion cracking (Fu et al., 2023).

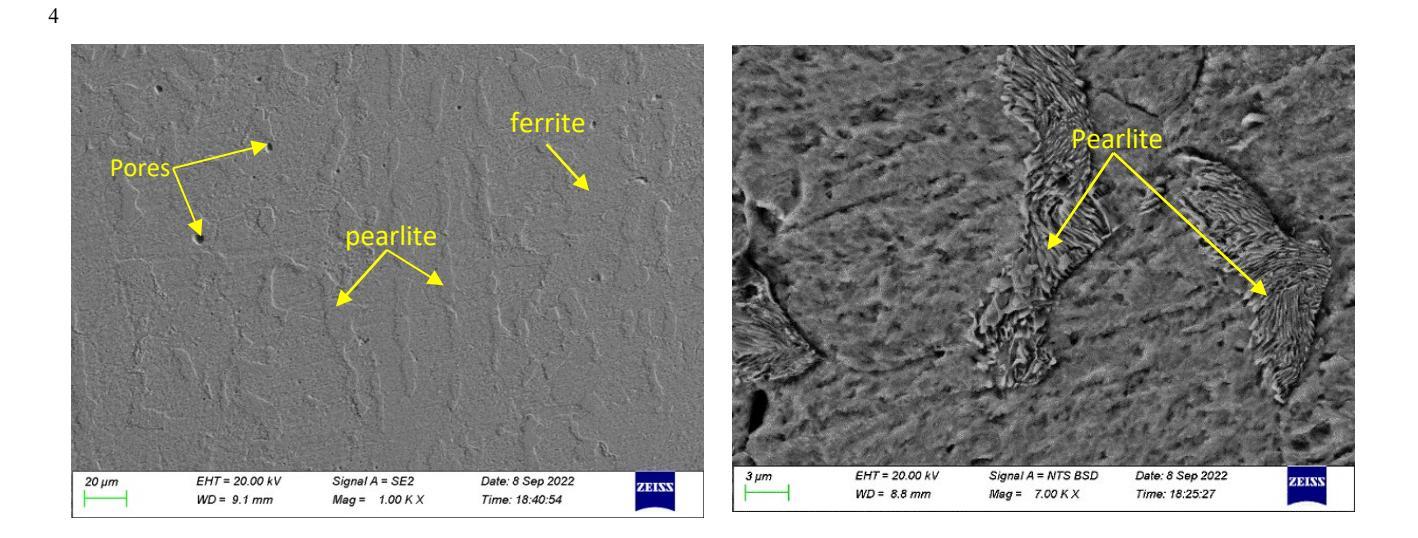
Fig. 4. SEM-BSE micrograph of the pipe under investigation.

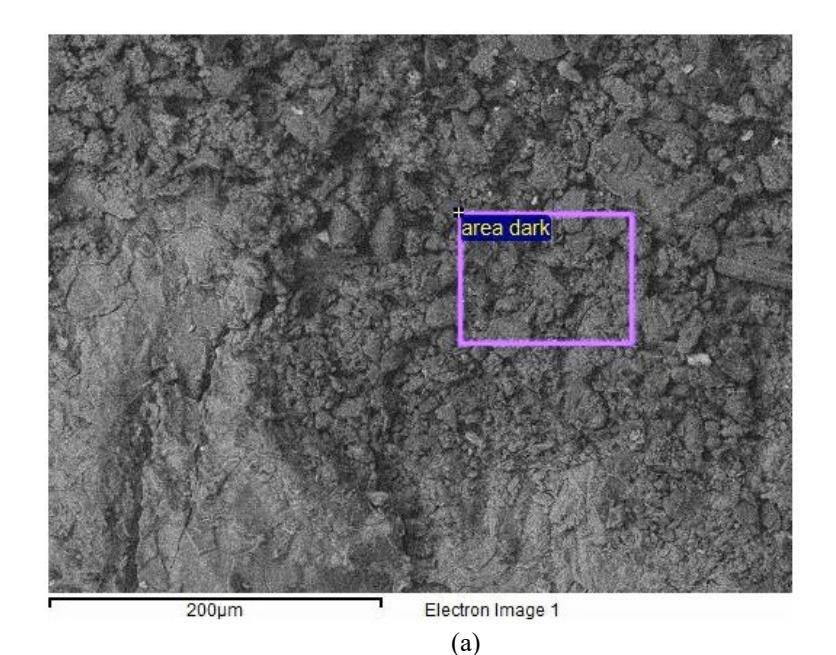
Fig. 5. SEM-BSE image and EDX of the steam pipeline surface.

The SEM/EDX equipment studied the surface corrosion of the steam pipe. Table 3 shows the EDX analysis results. The results revealed the presence of elements mainly Fe, O, Si, Na, Cl, Mg, Al and K, as shown in **Fig. 5** and **Fig. 6**. The quantitative composition of the geothermal scale shows that amorphous silica was the main constituent in a few salts. Other

scales include iron silicate, calcium carbonate and sulphide. There are various mechanisms of silica scaling formation by precipitation through evaporation, flashing, and supersaturation of water droplets carried over from the production-well separators (Takayama et al., 2000).

With a drop in temperature or pressure in the surface pipework, the liquid fraction will flush or boil, causing supersaturation for silica that would end up in silica deposition (Opondo, 2005). Corrosion occurs due to contact between the silica and metal surface. Corrosion occurs due to contact between the silica and metal surface, thus influencing erosion-corrosion behaviour. The formed deposits have an amorphous or crystalline structure that can promote localised corrosion beneath the pipe (Opondo, 2005). Geothermal fluids such as hydrogen chloride, hydrogen sulfide, and silica cause multiple corrosion mechanisms and scaling (Royani et al., 2021). Sudden changes in flow velocities of particle-invested geothermal fluids occasionally result in tribo-corrosion. This corrosion behaviour results in material loss, thus damaging the surface layers. The corroded steam base metal undergoes mechanical failure due to the condensate-induced water hammer effect due to fluid flow. The mechanism of erosion-corrosion in low-carbon steel results in a rough surface. This surface texture is due to cyclic plastic deformation and smearing of the material (Brownlie et al., 2021). The impacting particles easily remove the smeared material from the pipe surface.

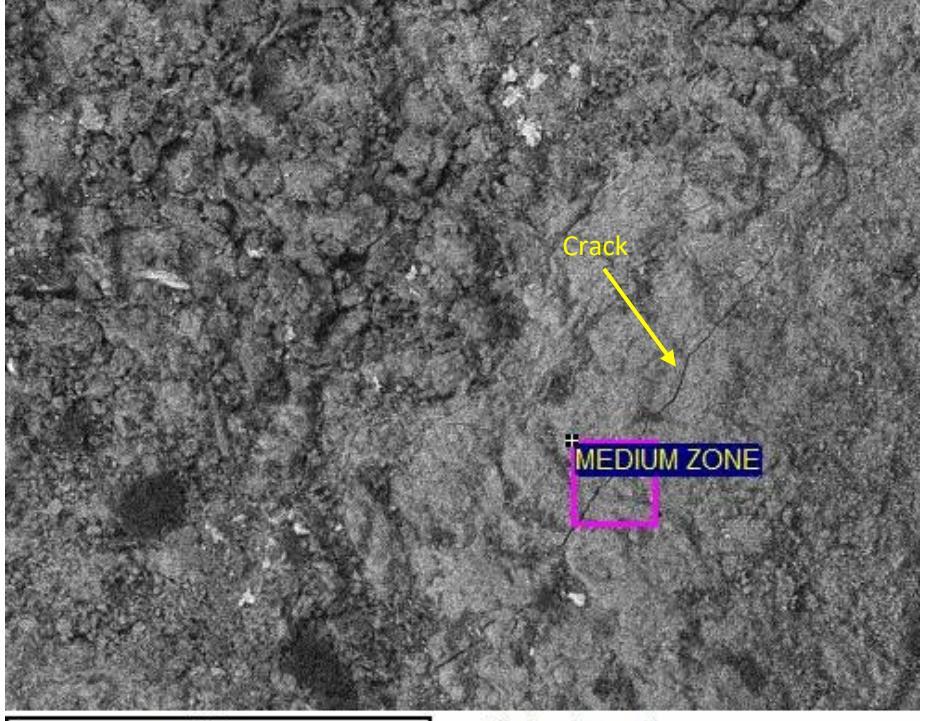
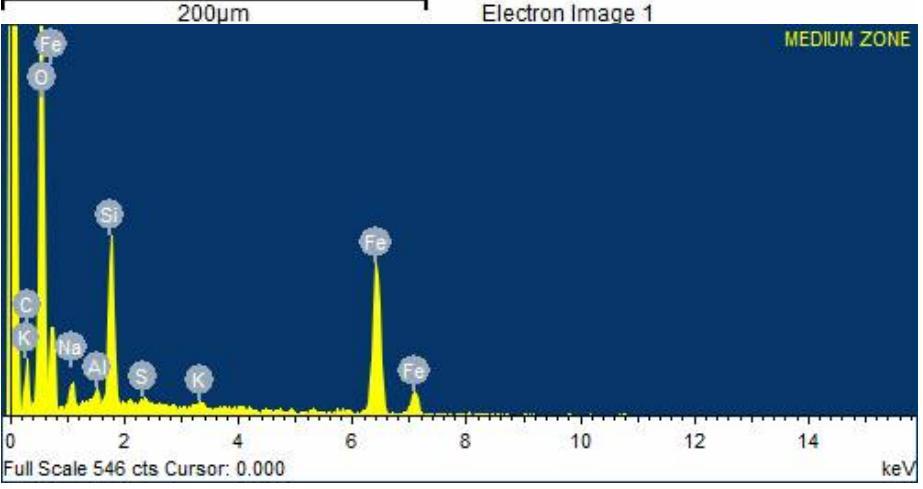
Fig. 6. SEM/EDX micrograph of the corroded pipe.
